PRINTMAKING STUDIO INSPECTION REPORT JANUARY 2014

This report focuses on creating a safe, non-toxic printmaking studio wherever possible.

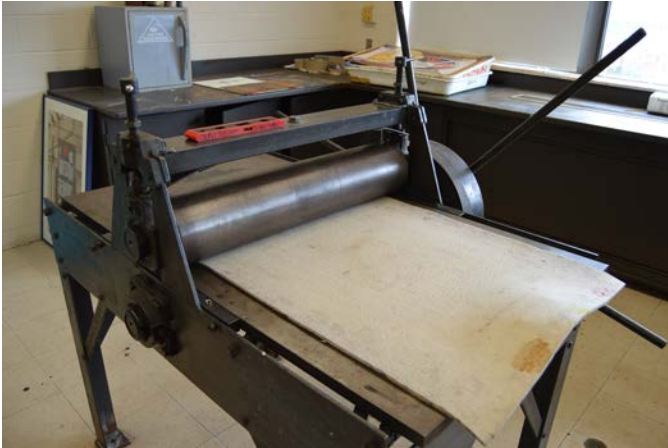
Both the 28 and 18 inch presses in Room 403 are in good working condition. The beds are free of nicks or marks that would effect printing, and move freely with the gear driven spindle. The rollers are free of damage.

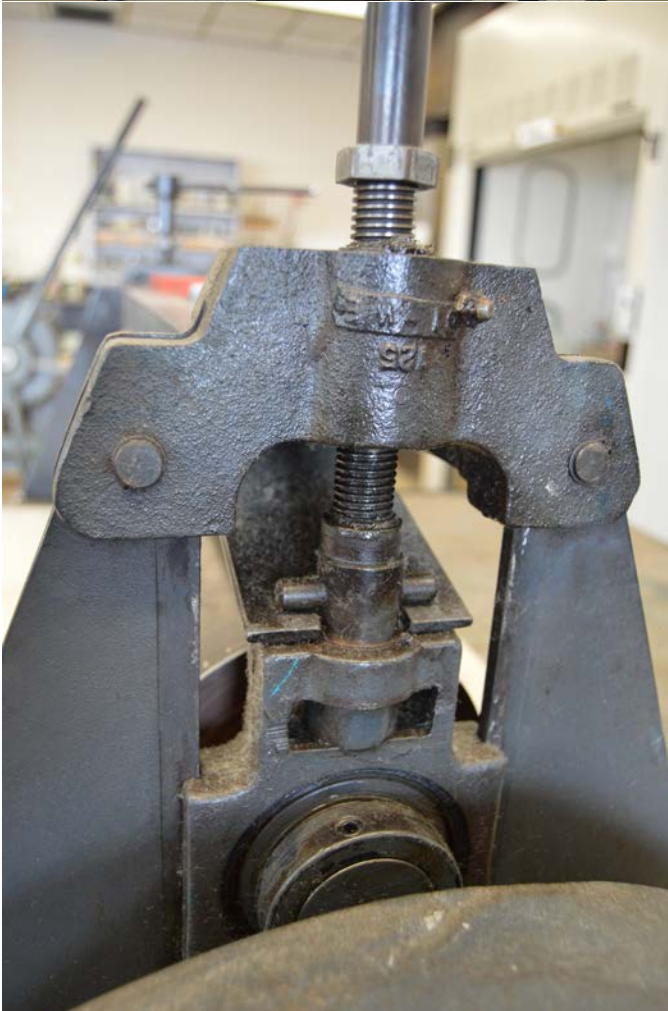
Neither press possesses a scale to determine the exact amount of pressure between the bed and the roller. This can be an issue if one side of the roller is lowered significantly more than the other, creating potential for stripping of the threads as seen in the photograph.

Clearly communicated signage will be installed to ensure that students do not strip the threads on the adjustment gauges.
